A2647 – Additive Manufacturing for NAVAIR

Repair of AV-8B F402 Engine Component due to Fretting Wear

The Aircraft Airworthiness
and Sustainment Conference

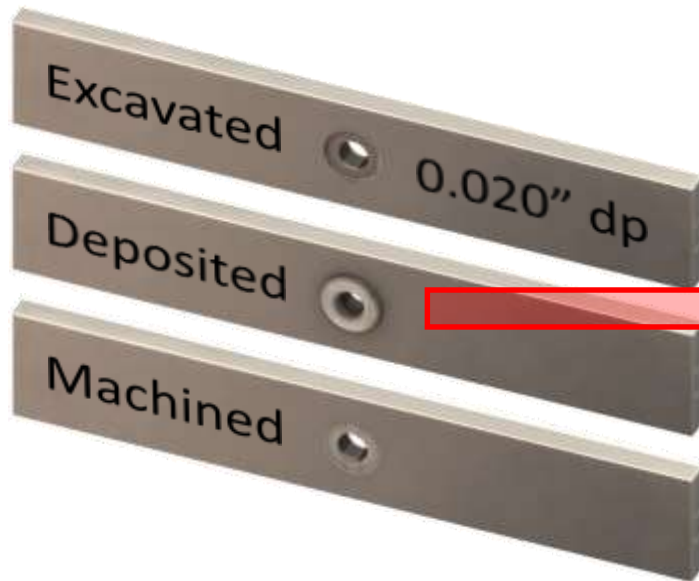
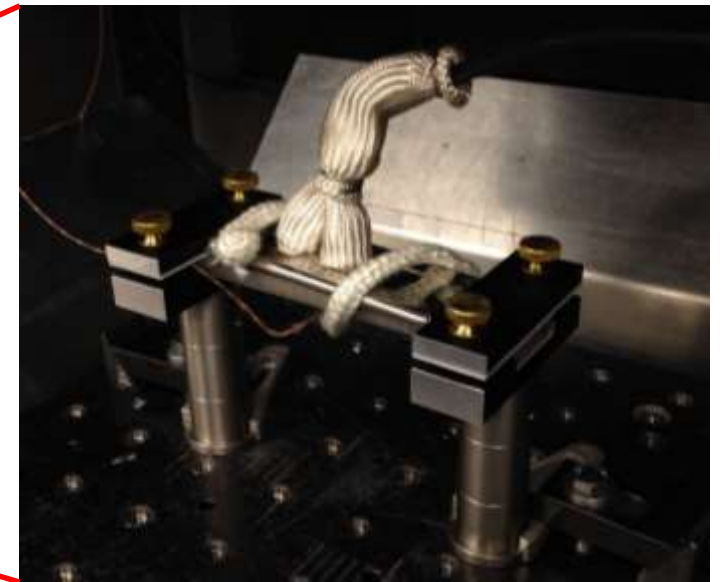
Test Coupon Preparation

1" x 6" x 0.225"

Optomec LENS system

Fixture w/ preheater

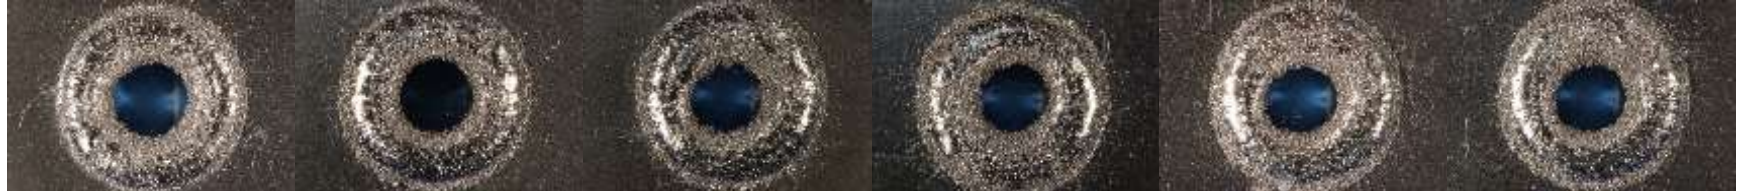
450 W with preheat

Coupon Deposition Images

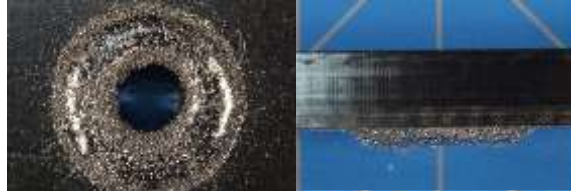
450 W with preheat

0.059 in, 4 layers, 0.020 in/layer

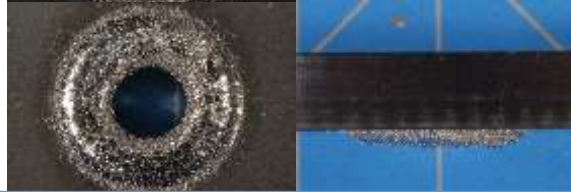
0.019 in

- CUBES thermo-mechanical finite element analysis (FEA) software is new and tailored specifically to additive manufacturing
- Trend of predicted distortion was unlike trend of measured distortion
- Minimum distortion, as measured from test coupons, corresponded to 450 W with preheat condition
- Acceptability of qualification test metrics will correlate with results specific to 450 W with preheat parameters
- Overall Distortion test will only be conducted using 450 W with preheat parameters

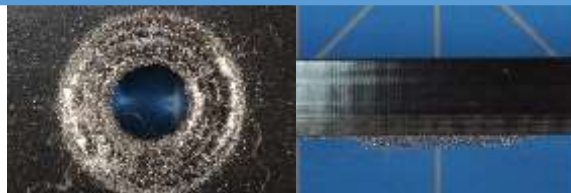
375 W with preheat

0.016 in

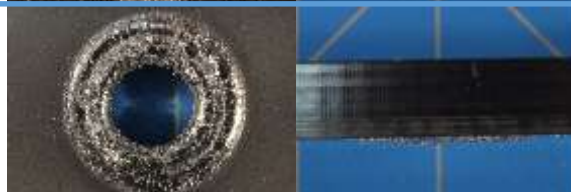
300 W with preheat

0.024 in

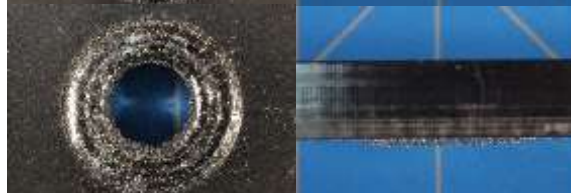
300 W

0.019 in

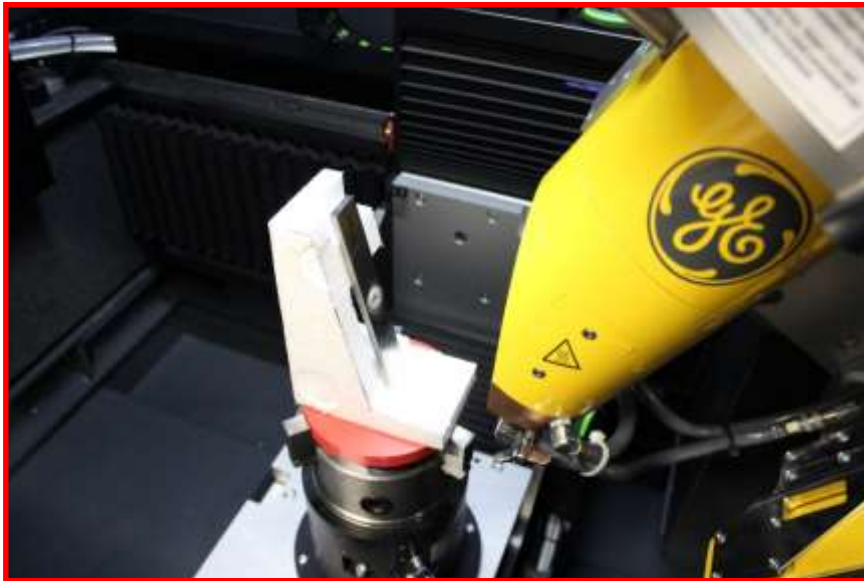
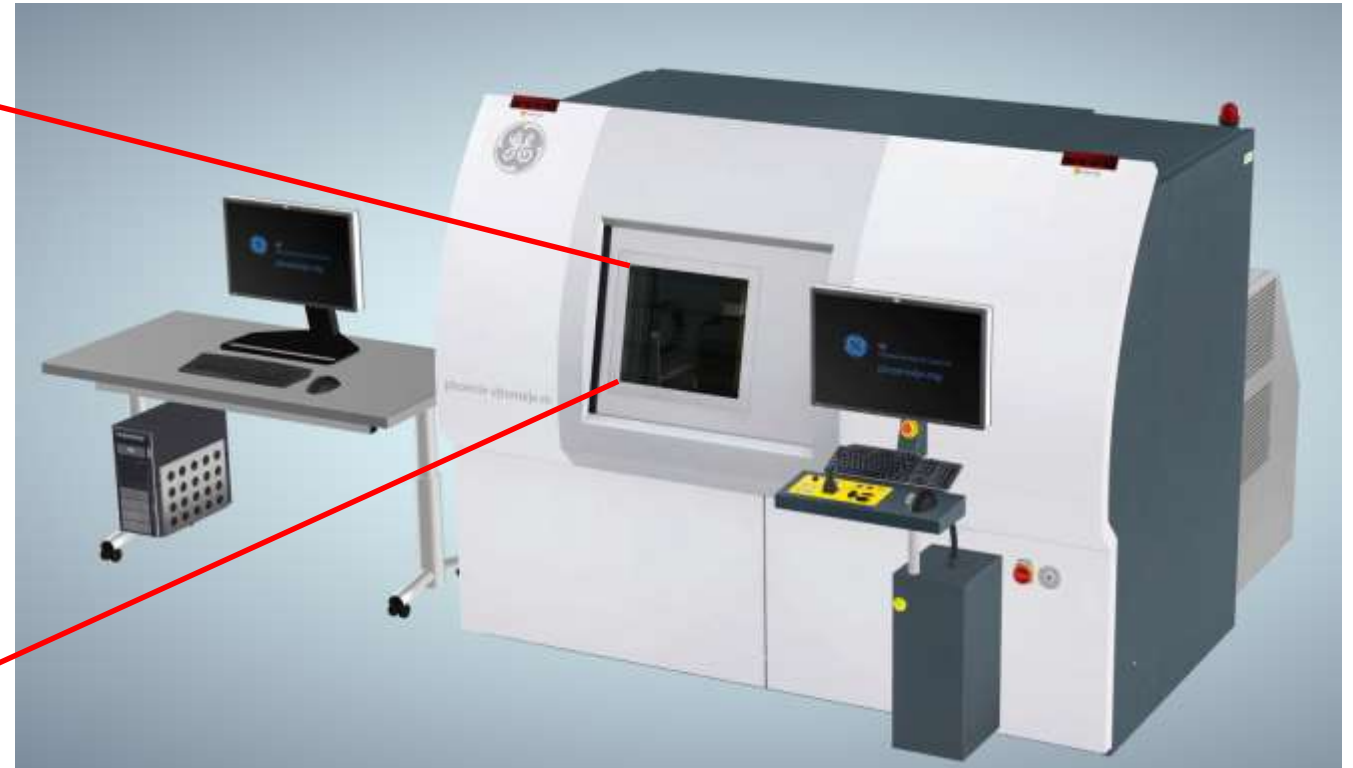
X-Ray (Computed Tomography) (Test 1/6)

- No voids greater than 0.004"

- All coupons were X-Ray (CT) tested
- No porosity greater than 0.004" in 450 W with preheat samples was observed ✓
- Porosity smaller than scan resolution (0.004") is suspected in most samples, but could not be confirmed
- One pore of ~0.004" was observed in a 450 W (without preheat) sample
- One pore of ~0.005" was observed in a 300 W with preheat sample

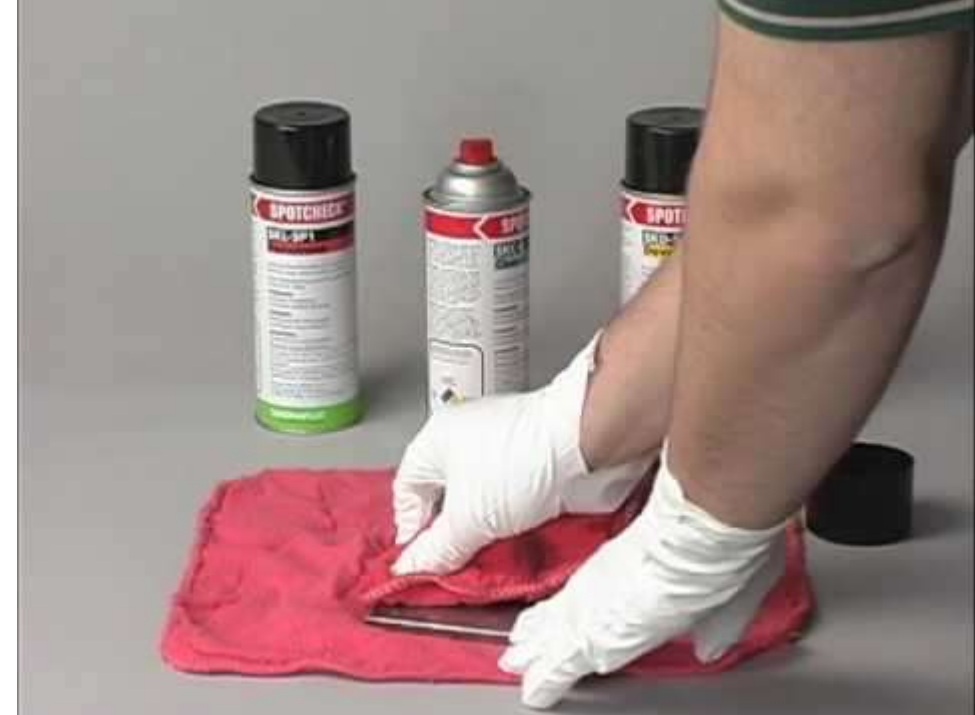
Liquid (Dye) Penetrant

- No observable defects (unaided viewing)

- All test coupons were dye penetrant (PT) tested
- No indications were observed in 450 W with preheat samples ✓
- Indications were only observed in the four samples that were repaired with a significant offset between the deposit and the hole/excavation
 - These indications mark lack-of-fusion areas where the deposit did not adequately overlap the substrate excavation wall
 - No lack-of-fusion surface cracks or porosity is thus expected for any of the tested parameters where the deposit is properly aligned with the excavated area, per design

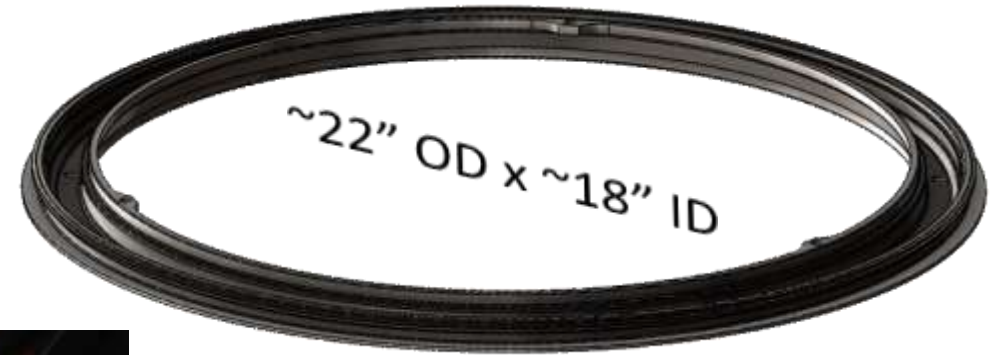
Seal Ring Preparation

Optomec LENS system

Heating cords

Thermal blanket

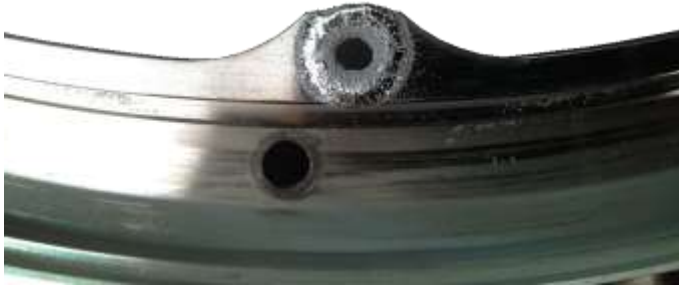
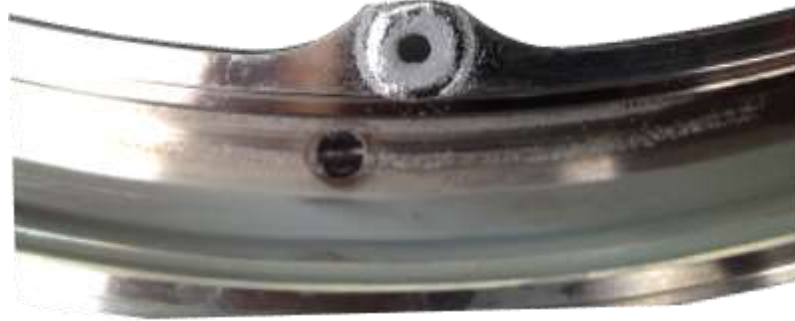
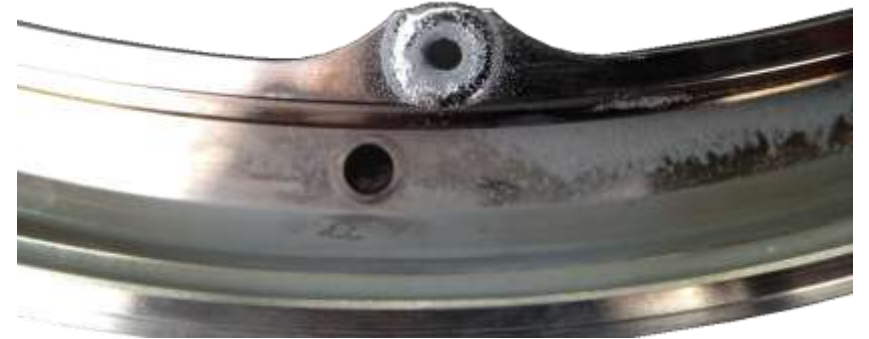
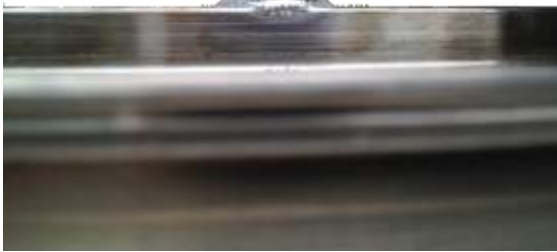
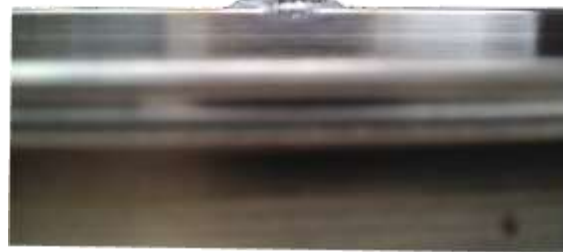
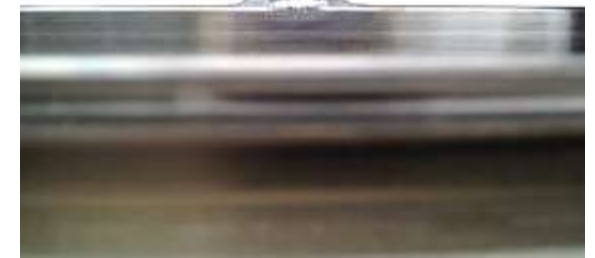
Seal Ring Deposition Images

450 W with preheat

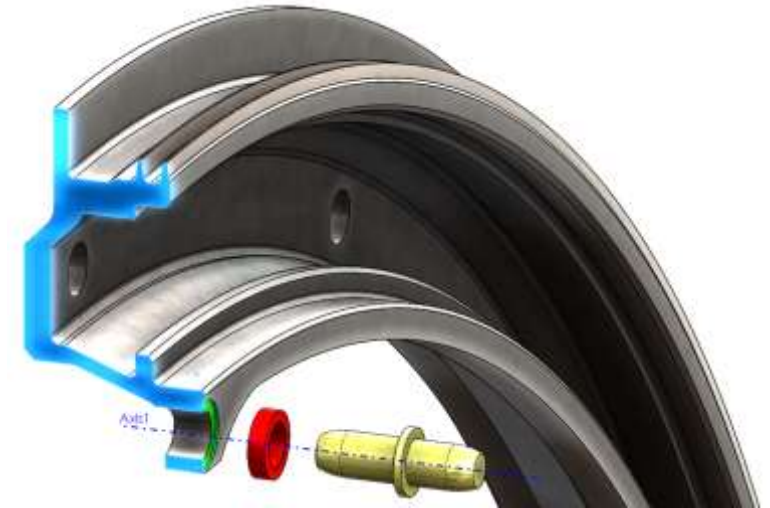
Overall Distortion

Before Repair

PART NAME : 0613011		January 12, 2016		15:26	
		REV NUMBER :		SER NUMBER : 001		STATS COUNT : 1	
18.4001 DIAMETER							
DIM LOC1= LOCATION OF CIRCLE DIA=18.40 UNITS=IN							
AK	NOMINAL	+TOL	-TOL	MEAS	DEV	OUTTOL	
0	18.4001	0.0008	0.0008	18.4791	-0.0014	0.0008	0.0008
TOP TO DATUM A PARALLELISM							
DIM PAR1= PARALLELISM OF PLANE F1R-UNDER, RES TO PLANE F1R-TOP, RES UNITS=IN							
AK	NOMINAL	+TOL	-TOL	MEAS	DEV	OUTTOL	
0	0.0000	0.0020	0.0008	0.0023	0.0022	0.0022	0.0022
FLATNESS							
DIM FLAT1= FLATNESS OF PLANE F1R-UNDER UNITS=IN							
AK	NOMINAL	+TOL	-TOL	MEAS	DEV	OUTTOL	
0	0.0000	0.0020	0.0008	0.0023	0.0023	0.0023	0.0023
DIM FLAT2= FLATNESS OF PLANE F1R-TOP UNITS=IN							
AK	NOMINAL	+TOL	-TOL	MEAS	DEV	OUTTOL	
0	0.0000	0.0020	0.0008	0.0014	0.0014	0.0014	0.0014

After Repair

PART NAME : 0613011		February 10, 2016		14:19	
		REV NUMBER :		SER NUMBER : 001		STATSCOUNT : 1

18.4001 DIAMETER

DIM LOC1= LOCATION OF CIRCLE DIA=18.40 UNITS=IN							
AK		NOMINAL		+TOL		-TOL MEAS DEV OUTTOL	
0		18.4001		0.0008		0.0008 18.4798 -0.0013 0.0008

TOP TO DATUM A PARALLELISM

DIM PAR1= PARALLELISM OF PLANE F1R-UNDER, RES TO PLANE F1R-TOP, RES UNITS=IN							
AK		NOMINAL		+TOL		-TOL MEAS DEV OUTTOL	
0		0.0000		0.0020		0.0008 0.0023 0.0022 0.0022

FLATNESS

DIM FLAT1= FLATNESS OF PLANE F1R-UNDER UNITS=IN							
AK		NOMINAL		+TOL		-TOL MEAS DEV OUTTOL	
0		0.0000		0.0020		0.0008 0.0023 0.0023 0.0023

DIM FLAT2= FLATNESS OF PLANE F1R-TOP UNITS=IN							
AK		NOMINAL		+TOL		-TOL MEAS DEV OUTTOL	
0		0.0000		0.0020		0.0008 0.0013 0.0013 0.0008

- One seal ring was received for testing
- Diameter and parallelism requirements were both out-of-tolerance upon receipt
- Diameter and parallelism deviations following repair deposition and machining were both within 50% of the manufacturing tolerance band from the as-received state

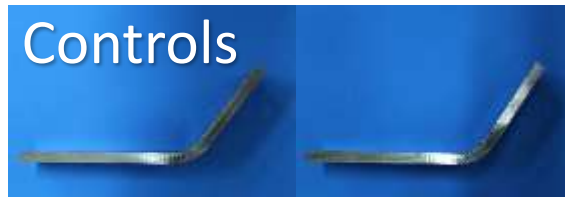
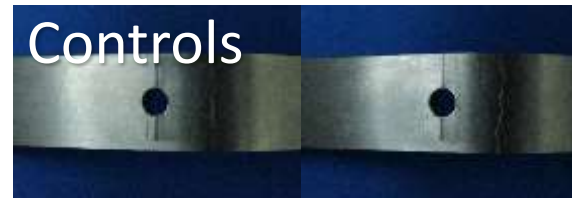
Guided Bend

- Defects \leq control coupons

- Two coupons from each parameter set and two control coupons were tested
- All but two coupons yielded prematurely within the substrate providing insufficient insight into the potentially more ductile region beneath the repaired areas
- Coupons (1 ea) prepared at 375 W with preheat and at 300 W with preheat were bent successfully through their repaired regions. Cracking was evident at the onset of bending, well before the repaired regions were stressed
- Cracking was observed at the suspected more-ductile perimeter of the repair region, but was unremarkable compared to prior yielding on the same sample
- Additional bend testing is recommended using a larger mandrel to reduce the elongation and early onset of yielding within the substrate

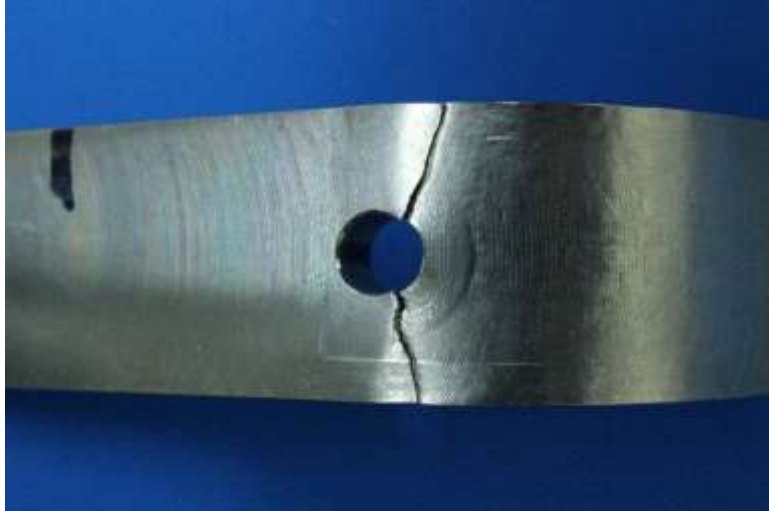
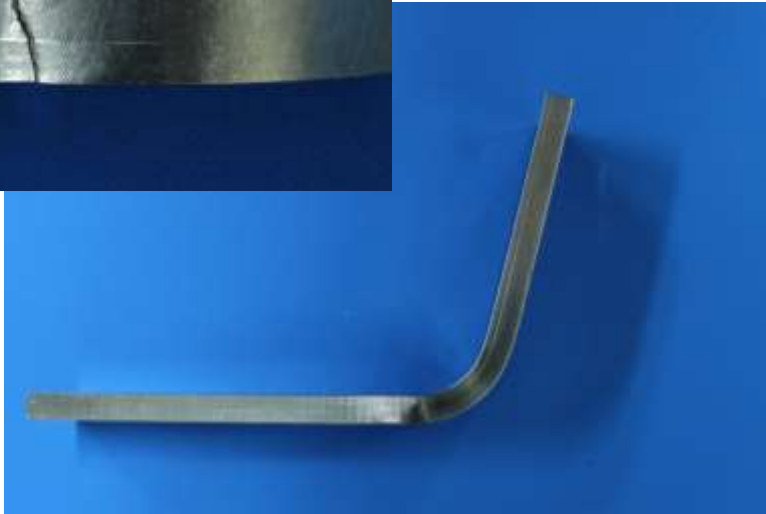
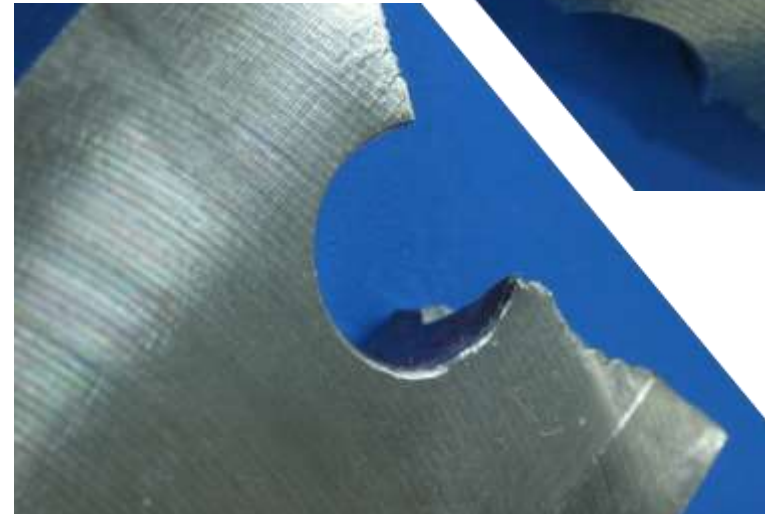
Guided Bend

375 W with preheat

Cracks
